# Parmenter Barn

## Londonderry Historical Society

**140 Pillsbury Road  
Londonderry, NH**

**Story Map**

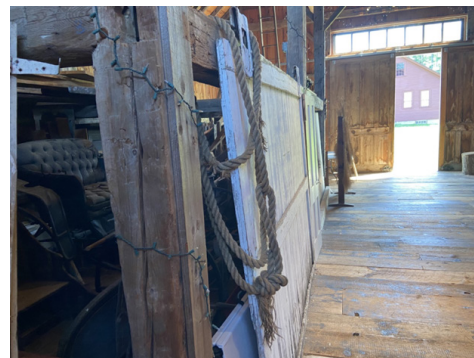
*Interior photo courtesy of  
Ryan Cutting*

The barn is a New England style dairy barn made of post and beam construction held together with mortise and tenon joints. It has doors in the gable ends with transom windows and a nine-over-six double sash window towards the peak. The interior has a long floor that runs parallel to the roof line. Farm wagons could enter from either end and drive the full length of this floor. There was space for hay storage on one side, and stalls for cows and possibly horses, on the other side. The second floor provided additional space for hay storage. Like most barns of the style, this one was three bays wide and three bays deep.

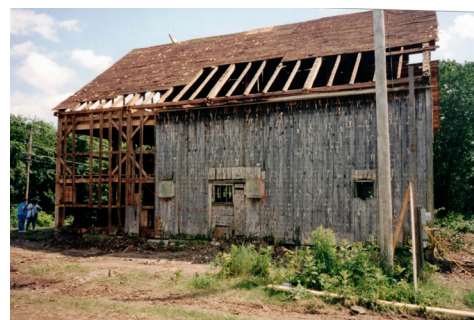
*Parmenter barn being dismantled  
by volunteers. Photo courtesy of the  
Londonderry Historical Society*

The property stayed with the Parmenter family until 1998, when the Londonderry Historical Society acquired the dilapidated barn to save it from being torn down. Historical Society volunteers dismantled the barn, piece by piece, and reconstructed it at its current location. The project took three years, with the work completed in the spring of 2001. A functional cupola was added soon after to improve cooling and ventilation. Today the Society uses the barn for exhibits and programs.
