# Red Barn

## Town of Sandown

34 Fremont Road  
Sandown, NH

Story Map

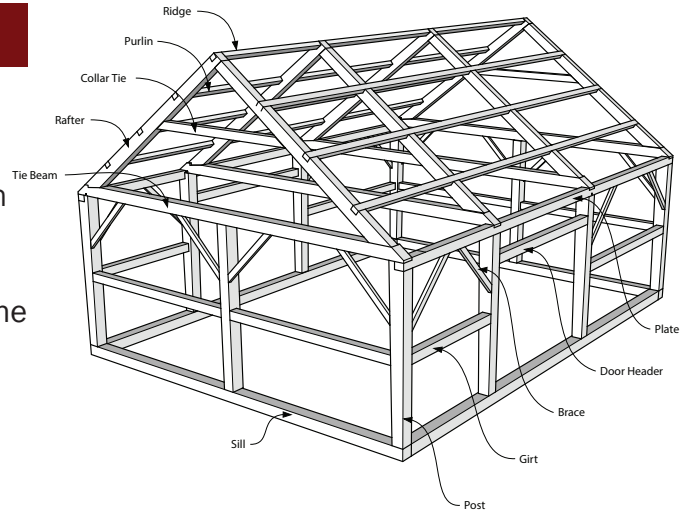
*English style barn timber frame components.  
Drawing courtesy of Jessica MilNeil of  
Preservation Timber Framing*

The Sandown Red barn is representative of an English-style post and beam barn, which is characterized by the placement of the barn door on the long side of the barn rather than the gabled end. Three-over-three windows on either end of the building let light in during the day. The barn's craftsmen used sawn and hewn lumber from hemlock and pine trees, fashioned together with mortise and tenon joinery, to frame the barn on top of

a stone foundation. Vertical posts and English tie beams hold up the roof and support the clapboard walls. The roof system is made of vertical boards held up by principal rafters and common purlins. Gunstock posts, which are wider at the top, hold up beams that support the roof truss's king posts and tie beams. A cupola sits atop the center of the building, and inside, a hayloft was used to store hay.
